TOMARK, s.r.o.
Division
TOMARKAERO / TOMARKAERO CZ

MANDATORY BULLETIN

Number: ZB SD4-03-2013

Name/Subject: Visual inspection and replacement of the front landing gear connecting flange without strengthening ribs

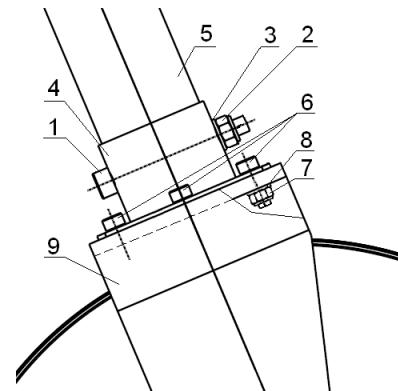
Dôvod vydania: occurrence of a cracked weld on the connecting flange without strengthening ribs of the front landing gear and its subsequent break

1. By loading the root of the horizontal stabilizer at the tail of the aircraft, lift the front landing gear wheel a few centimetres above the ground and support the front of the aircraft by a suitable support at the centre of the bottom edge of the firewall below the supporting L-profiles.
2. With a 13 mm wrench and a 6 mm hex key unscrew the nyloc nut (2) from the M8 bolt (1), securing the flange (4) on the front landing gear pipe (5) (see fig. to the right).
3. Remove the washer (3) from the bolt (1).
4. Pull the flange (4) with the fork (9) from the front landing gear pipe (5).
5. With a 10 mm wrench and a 5 mm hex key gradually unscrew the nuts (7) from the M6 bolts (6), remove the washers (8) and pull the bolts (6) out from the holes.
