TOMARK, s.r.o.
Division
TOMARKAERO / TOMARKAERO CZ

MANDATORY BULLETIN

Number: ZB SD4-04-2013

Name/Subject: Location of the sensing of the static pressure inside the rear of the fuselage

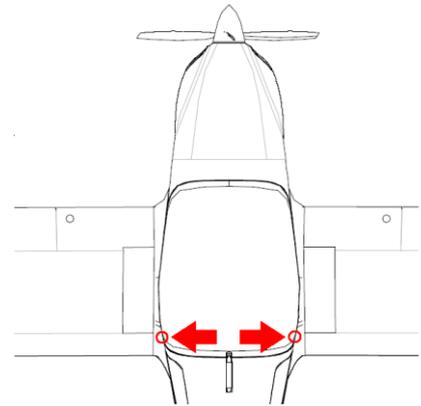
The original static pressure ports are located symmetrically on the sides of the fuselage, below the cockpit windows, as it is shown in the picture on the right.

The static pressure ports have a round shape and are riveted to the insides of the side fuselage skins in the upper part of the baggage area.

The static pressure ports are connected to plastic tubes $\text{Ø}6 \times 1$ mm, leading to the flight instruments located on the instrument panel. The tubes are secured on the static pressure ports by locking clips.

The original static pressure ports, located symmetrically on the sides of the fuselage below the rear window of the cockpit, cause an airspeed indication error in the critical area of stall speeds that is higher than 10 km/h, which may lead to dangerous situations.

With the help of pliers remove the locking clips and disconnect both tubes from the static pressure ports.

NOTE: The tubes may first be cut off, if necessary, close to the ports.
