TOMARK, s.r.o. Strojnícka 5 080 01 Prešov	<h1>SERVICE BULLETIN</h1>	No: SB_SD4-02-2022
		Date: 30.JUN 2022
		Revision: Initial issue
		Date: -
		Number of pages: 4
Approval:	SB approved under EASA MINOR CHANGE APPROVAL 10079890

MODEL AFFECTED:	Viper SD-4 RTC aircrafts Viper SD-4 Night-VFR aircrafts
APPLICABILITY:	All aircrafts in conformity with EASA.A.606
SUBJECT:	P/N: SD4-A-1-509-L-7 - Engine mount bottom bracket outer stiffener – left, and P/N: SD4-A-1-509-R-7 - Engine mount bottom bracket outer stiffener – right ATA System: 71-40 Power Plant Attach Fitting
COMPLIANCE:	Implement this Service Bulletin when airplane is extensively used e.g. for pilot training and there is knowledge or suspicion of a hard landing or bounced landing/PIO or executed unintentional spin with possibility to exceedence of published load factor or exceeding the published load factor (g-force limit +4g ÷ -2g). Recommended for all aircraft in service.
DESCRIPTION:	Front edge of both engine mount bottom bracket outer stiffeners in place of stiffener and bottom engine mount connection point near fitted bolt hole.
REASON:	Based on investigation executed on one of Viper SD-4 RTC aircraft there was identified c

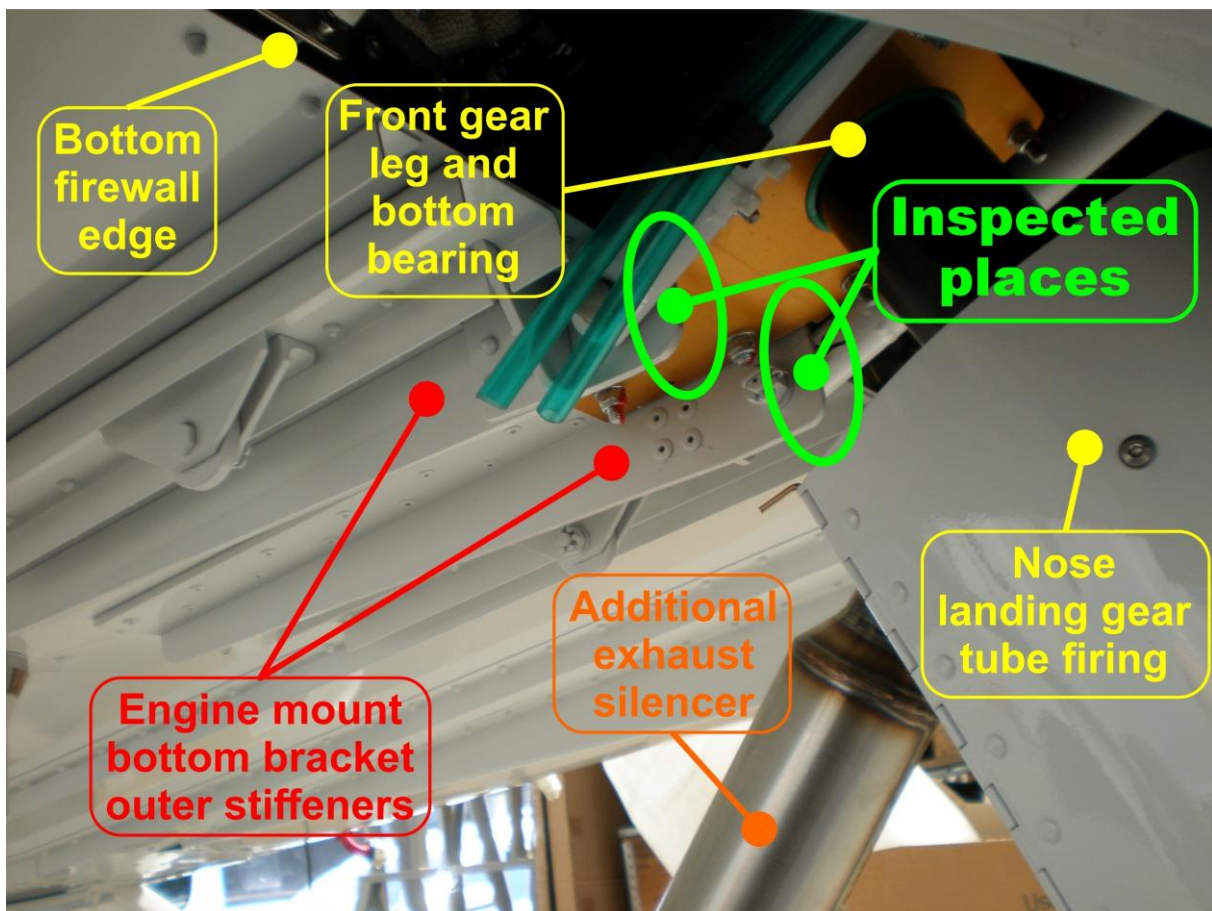
- ! Park the airplane in a sufficiently large parking area.
 - ! To prevent accidental movement, secure with a parking brake in the airplane's cockpit (see /2/) or secure the wheels with chocks.
1. Identify the places for inspection on the bottom side of the fuselage /2/ – just in the middle under bottom firewall vs bottom fuselage skin connection edge at the front part of the engine mount bottom bracket stiffeners in place of connection of the engine mount bottom beams and near fitted bolts.
See figure below for better orientation.

Legend: The view is pointed to inspected places from the right side of the nose landing gear tube firing.

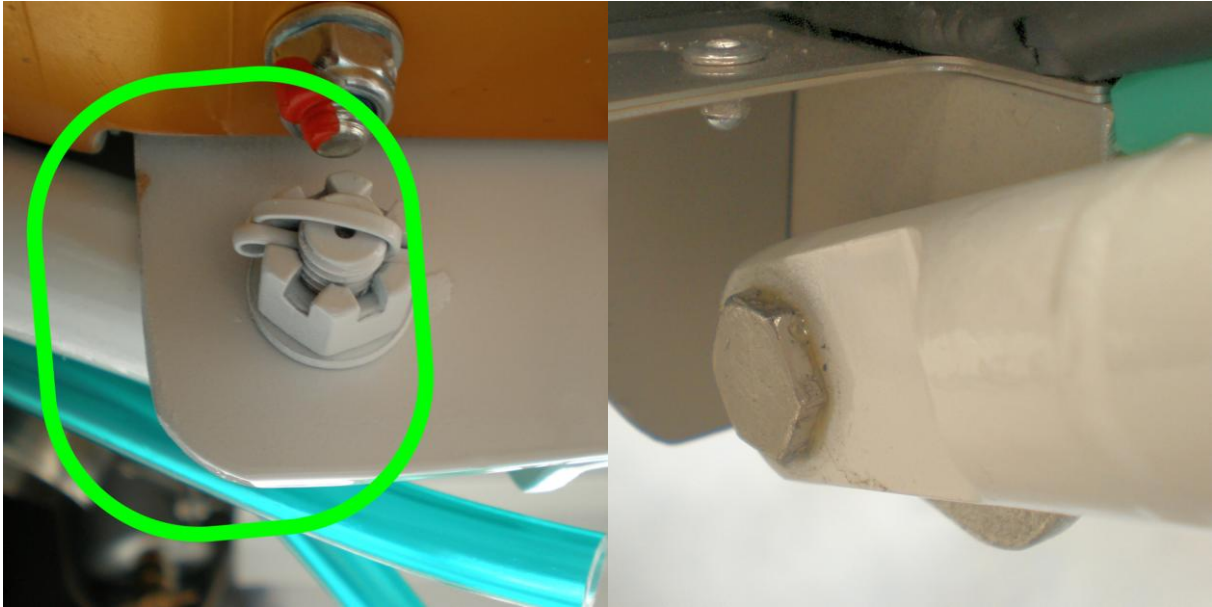
3. Execute detailed visual inspection of front edge of the right engine mount bottom bracket outer stiffener (P/N: SD4-A-1-509-R-7 /2/) in place of stiffener and bottom engine mount beam connection point near fitted bolt hole. Check whole place between front edge of stiffener and fitted bolt spacers on both sides of the stiffener (head and nut) for crack(s). If needed and suitable use any optical instrument for non-destructive testing or even liquid penetrant testing method, if applicable.

See figure below for better orientation - view of the inspected area of the right stiffener front part from the nut and from the fitted bolt head.

1. In case that any crack was detected contact TOMARK, s.r.o. with information about technical data of respective aircraft and send an evidence about detected crack – clear and good readable photo documentation, immediately.
2. Make records to the airplane documentation (Service Log-Book) – regarding this Service Bulletin accomplishment and identified state.
3. If any crack was not detected send information about the bulletin implementation to airplane manufacturer with evidence; e.g. copy/photocopy of records in airplane documentation (Service Log-Book).

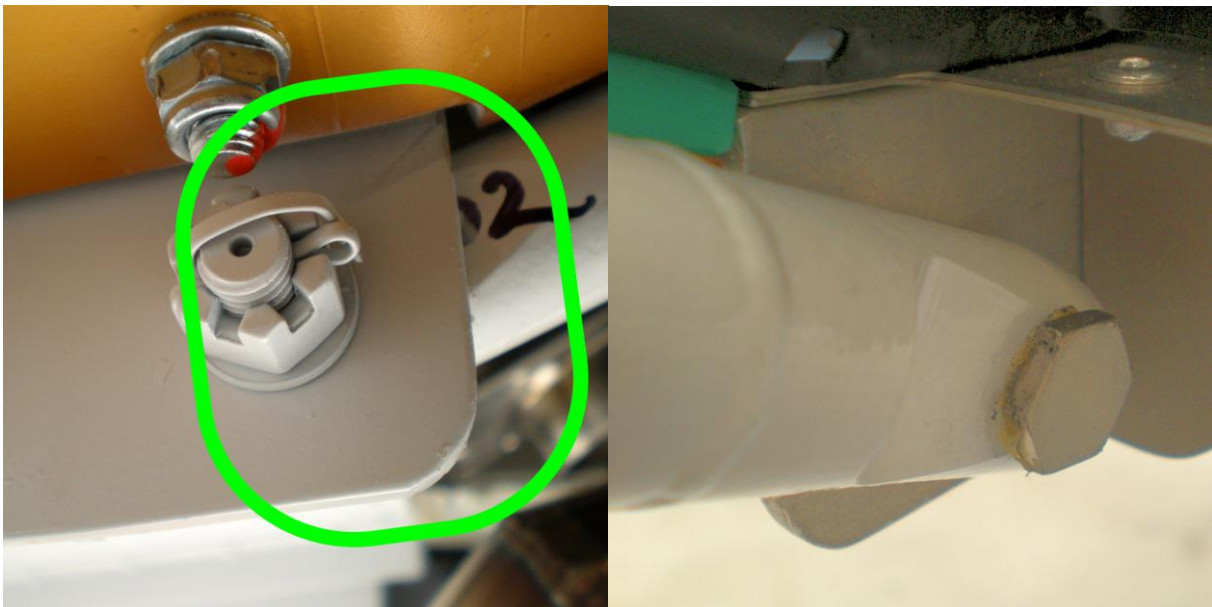
4. Execute detailed visual inspection of front edge of the left engine mount bottom bracket outer stiffener (P/N: SD4-A-1-509-L-7 /2/) in place of stiffener and bottom engine mount beam connection point near fitted bolt hole. Check whole place between front edge of stiffener and fitted bolt spacers on both sides of the stiffener (head and nut) for crack(s). If needed and suitable use any optical instrument for non-destructive testing or even liquid penetrant testing method, if applicable.

See figure below for better orientation – view of the inspected area of the left stiffener front part from the nut and from the fitted bolt head.
